# Tower Travails

*An ornate Italianate's leaning tower gets a new lease on life thanks to a series of innovative repairs.*

◆ STORY AND PHOTOGRAPHS BY  
BRUCE ROSENBAUM ◆

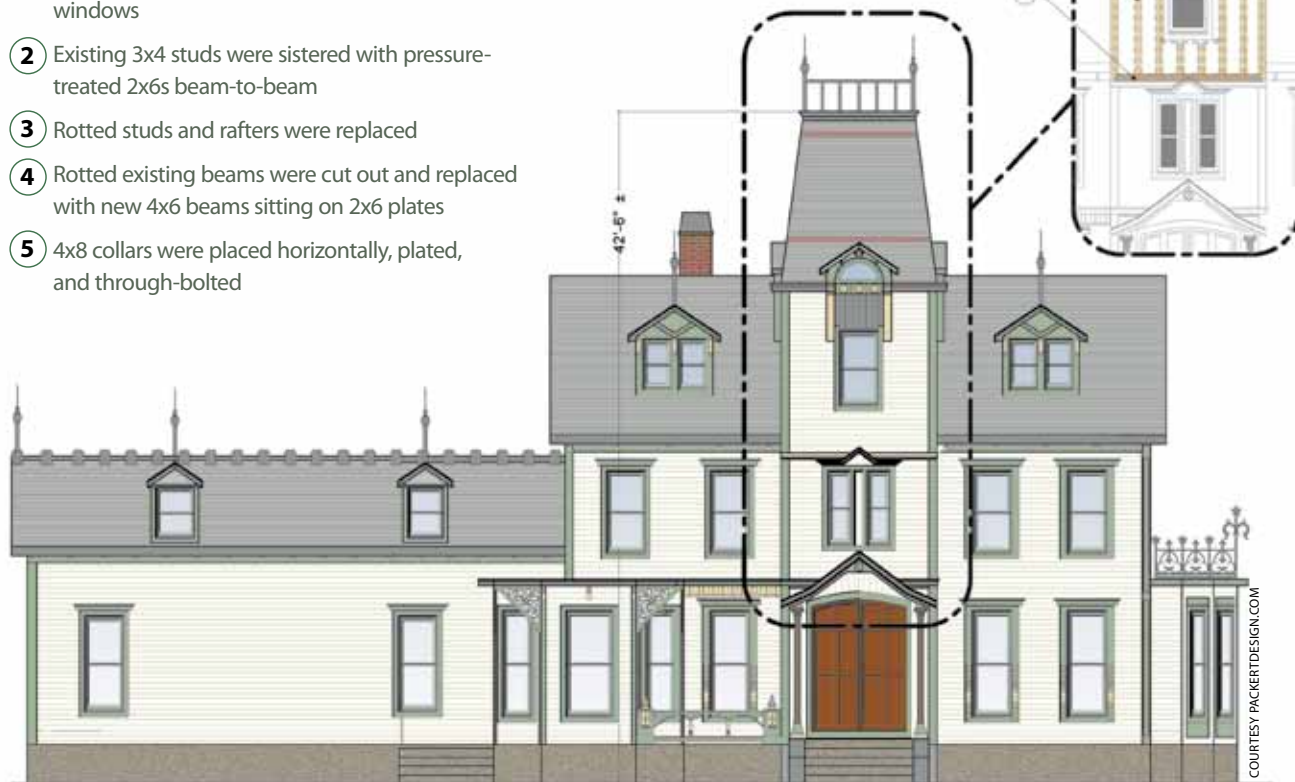
# Structural Solutions

- ① 4x6 headers were installed over all doors and windows
- ② Existing 3x4 studs were sistered with pressure-treated 2x6s beam-to-beam
- ③ Rotted studs and rafters were replaced
- ④ Rotted existing beams were cut out and replaced with new 4x6 beams sitting on 2x6 plates
- ⑤ 4x8 collars were placed horizontally, plated, and through-bolted

The next steps involved sistering walls with 2x6s run floor-to-ceiling. Any rotted studs were cut out and replaced with doubled-up 2x6s. After everything was shored up and the walls were supported, the team worked on replacing the old beams. Most contractors simply take an old beam out

and put a new one in exactly the same way, but Eric's team used a different technique. As they removed each old beam using sawzalls and skill saws (or chisels where the saws couldn't reach), they overcut into existing studs so they could make a new level line on the wall studs. This allowed for a new 4x6 and a plate (a pressure-treated 2x6 turned on the flat), which was installed beneath the 4x6. The beam sistering continued up to the roof in this fashion.

To further brace the massive slate roof, Eric's team also created a new lateral support system in the uppermost portion of the tower. The team took four 4x8 beams, notched them where they intersected, carriage-bolted them through where they sistered, and placed angle irons at the crossings. The resulting support structure looks like a pound sign atop the tower's interior.

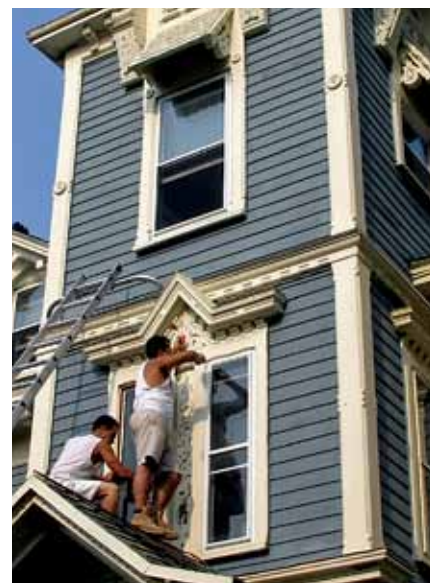
**Craftsmen stripped and painted exterior decorative elements, and restored windows.**

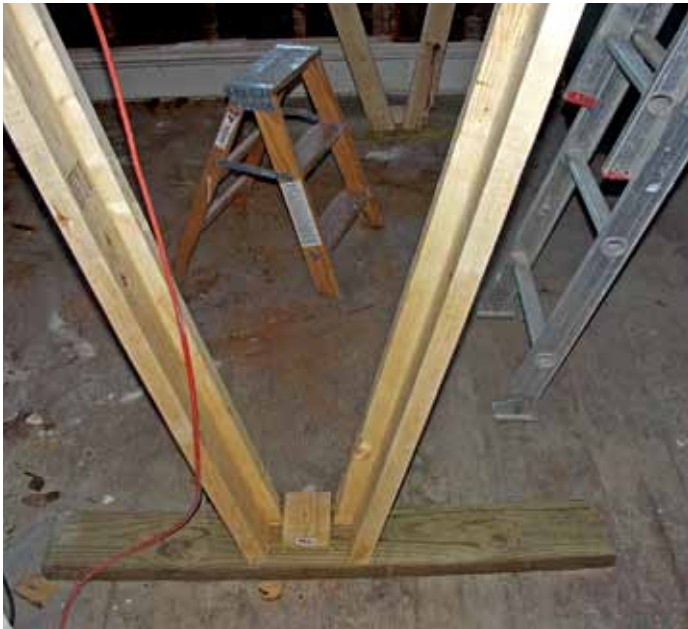
**During the work, V-shaped supports propped up lateral temporary shoring; the system was moved daily to access new work areas.**

To begin, Eric and his team of talented carpenters built temporary floors out of 2x10s. The new floors gave the walls lateral support, and they acted as a staging area for the construction crew. Next, the

team back-braced the walls with lineal 2x6s installed as wall-to-floor braces on an angle. This made for a great temporary support system, but it was one the team had to continually rip out, move, and rebuild in order to access new areas within the confines of a 10' by 10' space.

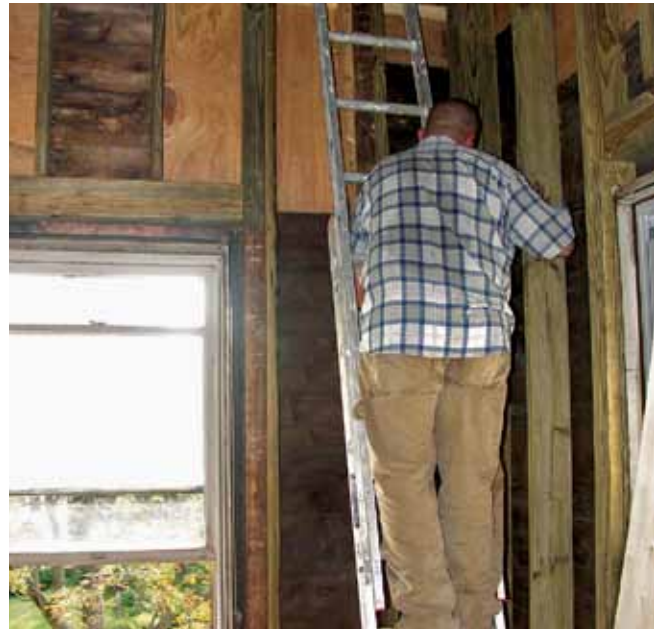
**Installing new framing and sistering beams were critical to shoring up the tower.**

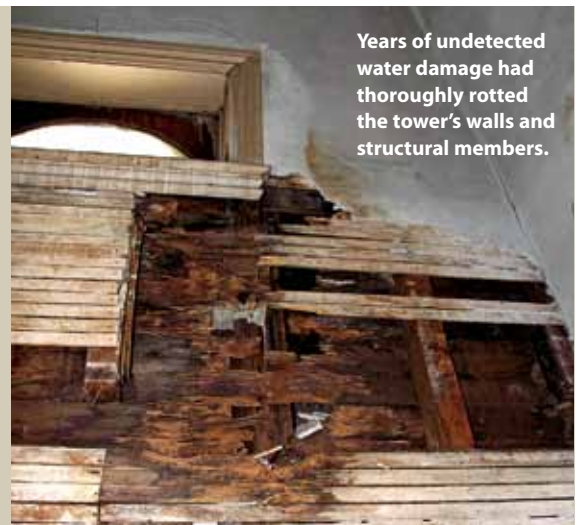
**Years of undetected water damage had thoroughly rotted the tower's walls and structural members.**

After purchasing the home and removing two damaged floors and some interior tower walls, we learned that our tower had seven rotted support beams—the result of years of undetected water damage. Worse

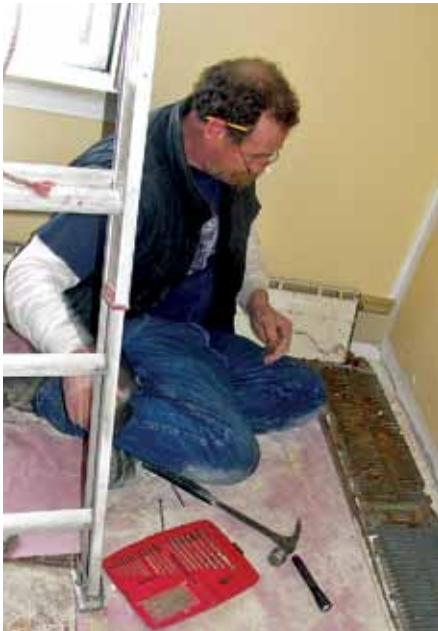
**Inside the tower, tight space proved challenging for the work team to negotiate.**

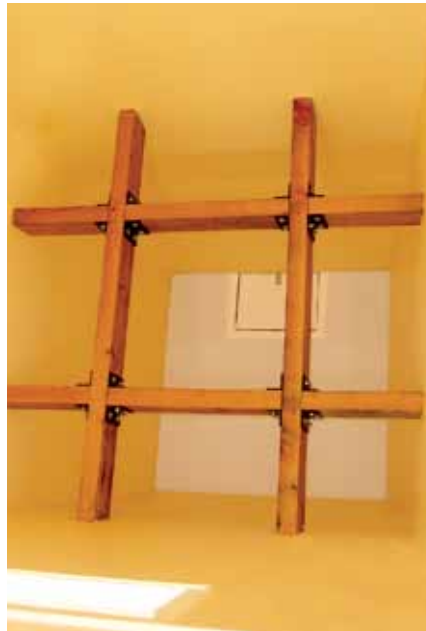
**Atop the finished tower's interior, 4x8 collars placed horizontally (and plated and through-bolted) add extra support.**
